In-depth intercity bus crash investigation: Case study of fire-gutted bus in Thailand

4. Results and discussion: Case study of fire-gutted bus

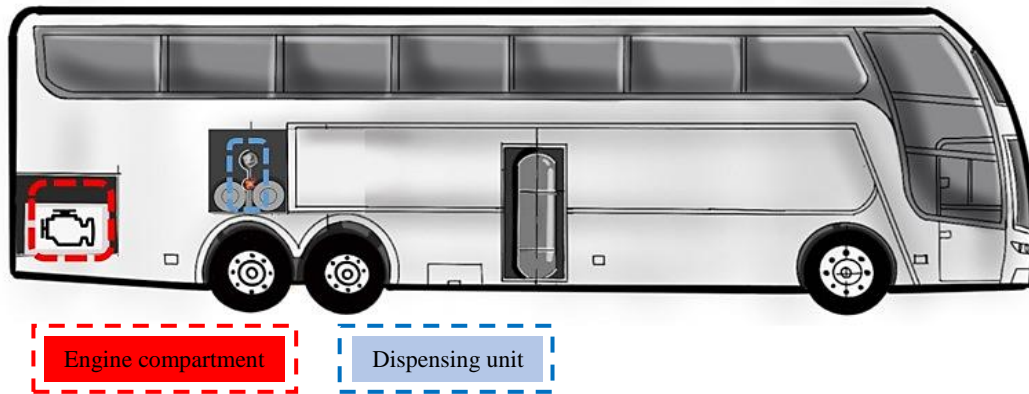
After extinguishing the hazardous fire on the CNG double-deck bus, a flat-bed truck and mobile crane were used to move it to the police station. The details of the vehicle body in this case study are shown in Figure 4. To investigate the active safety components in detail, our researchers with technicians were allowed to disassemble the key components in the wheels for the brake system. The components and installation of the CNG system are also explored together with the engine compartment for the enhancement of safety measures. The influence of the explosion on the vehicle structure was investigated.

Figure 4 Vehicle body of the CNG bus for the case study.

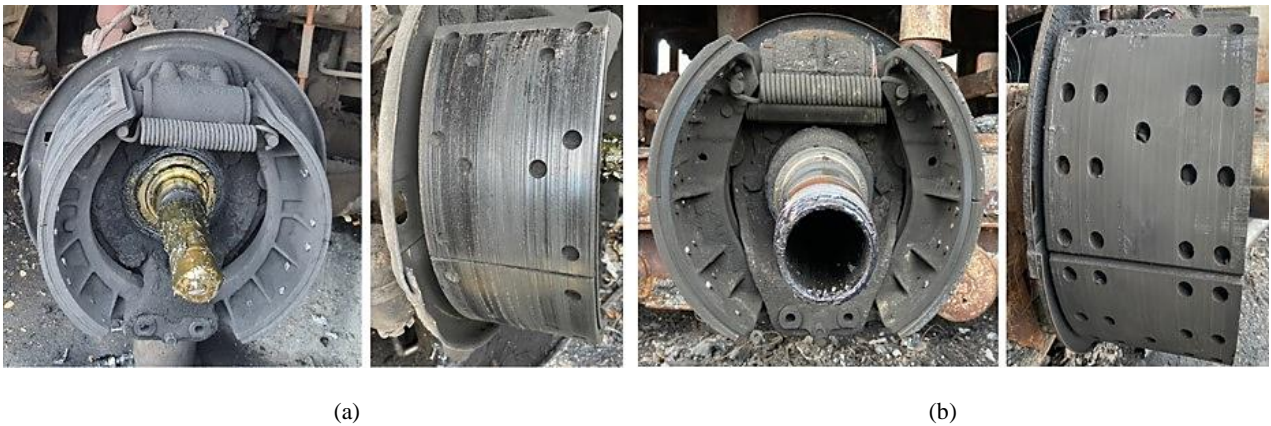
As shown in Figure 5, there were three axles in the fire-gutted bus, with only one remaining tire in the front axle. Each wheel for each axle was disassembled together with the drum brake. The evidence revealed that the bus had two different types of braking systems. The air-over-hydraulic brake system was used in the front- and middle-axle wheels, as shown in Figures 5(a) and 5(b), respectively. Alternatively, the rear-axle wheels were controlled by the air braking system, as shown in Figure 6. However, different types of braking systems in terms of different components and characteristics can be accepted in United Nations Regulation No. 13 if the vehicle can pass braking performance tests such as Type-0 (cold brake test), Type-I, (fade test), Type-II (downhill behaviour test), Type-III (fade test for vehicles of category O4), and Type-IIA (endurance braking performance test).

Figure 5 Air-over-hydraulic system: (a) front-axle wheel; (b) middle-axle wheel.

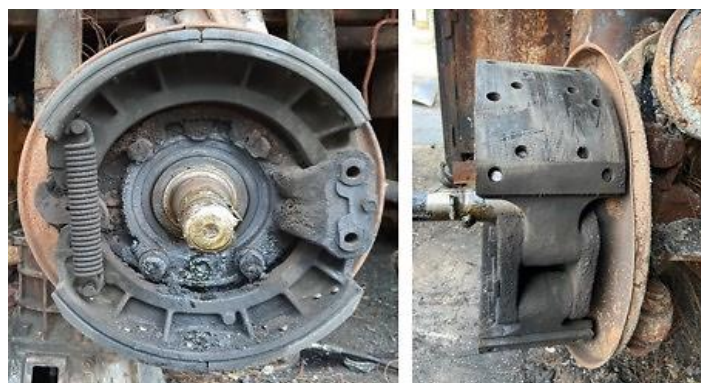
Figure 6 Air brake system in the rear axle wheel.

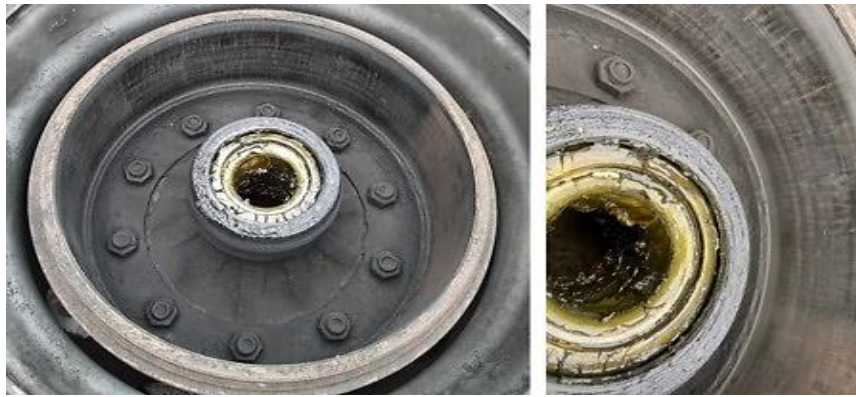
Figure 7 Small cracks on the drum brake surface at the front-axle wheel.

As shown in Figure 7, small cracks on the surface of the drum can be found in the front wheel of the bus, which passed the brake test as part of the periodical inspection from the DLT. The wear debris of the brake pads is shown in Figure 5 (a). These can be interpreted as conditions of strength loss in the drum brake and pad materials. The crack developments are related to thermal stress between excessively high temperature at the rubbing surface and low temperature at the surface gradient during the brake application [36]. During the cooling period, the temperature gradient at the drum brake can be reversed, resulting in the cyclic loading and thermal fatigue of the material. The high surface temperature of the brake pads also involves the wear debris and the mechanism of the brake pad [37]. Furthermore, a large vehicle mass that dominates large kinetic energy under high speed should be considered as high thermal loading in the vehicle brake system. The research work in the evaluation of different material compositions from aftermarket brake pads showed different wear characteristics [38]. For these reasons, the development of surface cracks in the drum brake and wear debris in the fire-gutted bus reveal the poor performance of the brake system together with the selection of pad materials under vehicle usage conditions. Therefore, there are many research topics in both material and design to enhance the brake performance based on these results under various driving conditions.

Consequently, the DLT in Thailand should enhance the brake test protocol for new bus registration. The protocol should cover the Type-I test (fade test) with continuous braking and the Type-II test (downhill behaviour test), which are mandatory in Vehicle Regulation No. R13. To avoid tire explosions in public buses and poor vehicle dynamic performances, the TPMS should also be set as a mandatory item in vehicle regulation.

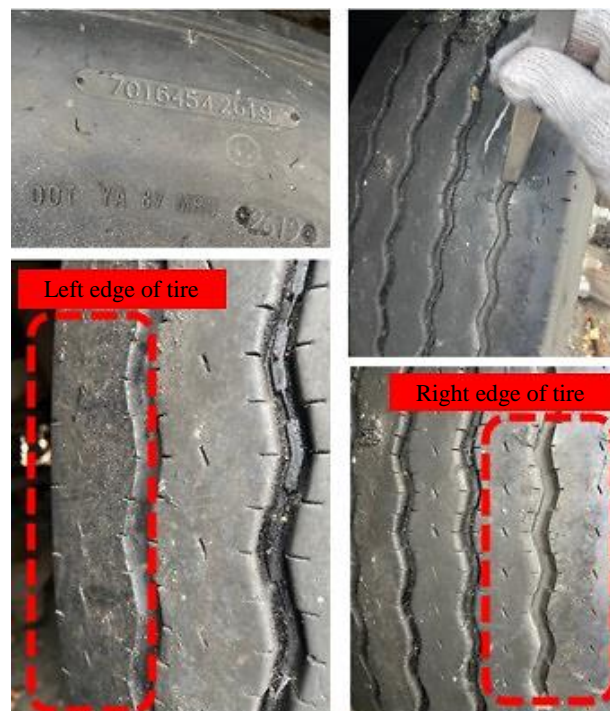
In addition, the remaining tire (approximately two years old) in the front wheel bus showed high wear at both edges of tire-pavement contact, as shown in Figure 8. Tire wear can reflect the non-uniform distribution of tire-pavement contact stress that is related to tire pressure [39]. For tire wear in a vehicle, there are many impact parameters, such as low tire pressure, high ambient temperature, high-speed driving, and increases in the sprung mass and side slip angle [40]. Poor tire wear with degradation phenomena can cause unstable vehicle performance because tread removal affects thermal and frictional tire characteristics [41]. However, tire pressure has a major influence on vehicle instability given the rapid change of tire properties under pressure loss [42]. Therefore, applicable technologies such as electronic stability control (ESC) and the TPMS are essential to avoid vehicle instability. However, the performance of such technology is necessary to be evaluated under various driving and usage conditions.

Figure 8 Tire condition of the front wheel of the bus.

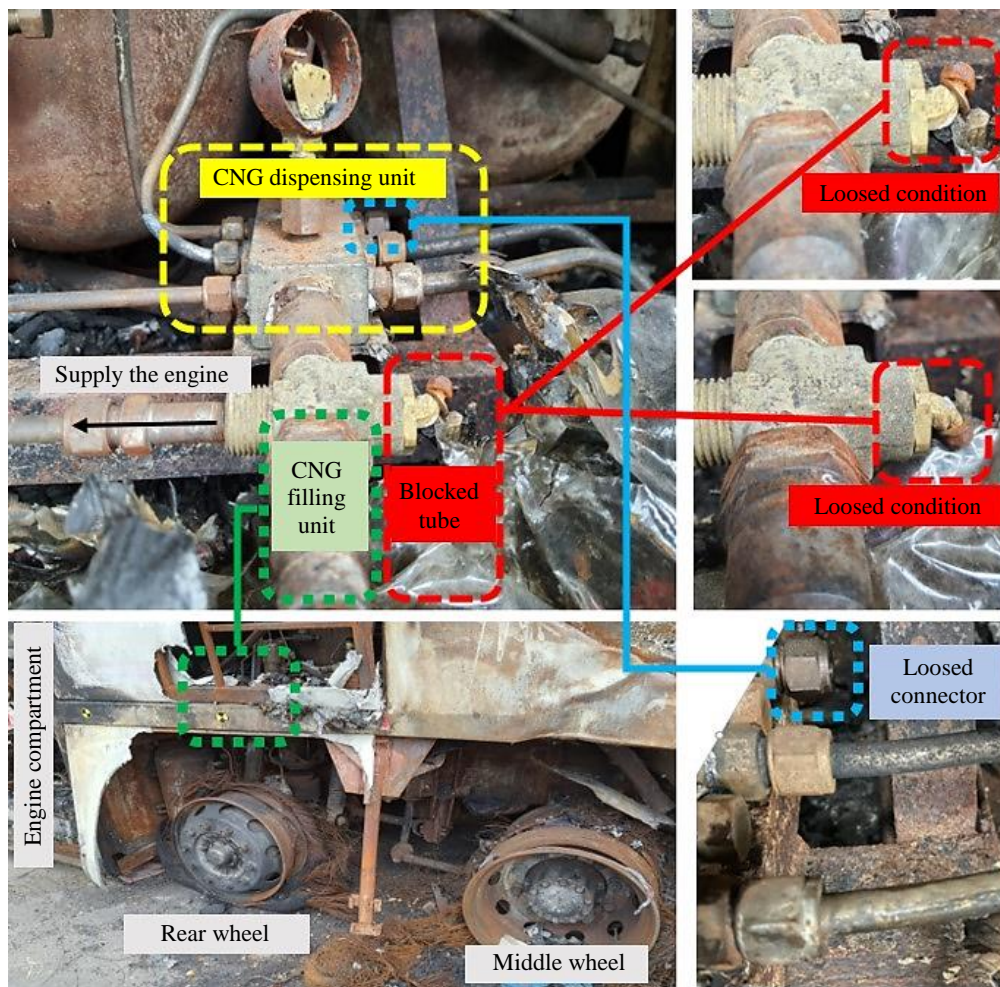
In the fire-gutted bus, the CNG containers did not burst because the PRD in each container operated functionally. Some horizontal containers can be located close to the engine compartment given heat protection for preventing higher surrounding temperatures than specific values from the containers' manufacturers, as mentioned in TISI No. 2333-2550 [27]. Furthermore, a CNG dispensing unit that was not one of the 15 standard components from United Nations Regulation No. 110 was found near the CNG filling unit, as shown in Figure 9.

Normally, the CNG dispensing unit is used for quickly filling all the CNG containers, especially in large vehicles, for long-distance trips in Thailand. The output of rigid fuel lines from the CNG dispensing unit can be connected to all the CNG containers as a parallel circuit. Without the CNG dispensing unit, all the CNG containers can be connected as a serial circuit, which take longer to be filled. Although the DLT-authorized inspector performs yearly CNG leakage tests through both virtual inspection and measurement, the CNG dispensing unit and the blocked tube, including the related connectors, can be loosened from vibration under operation, as shown in Figure 10. Therefore, the CNG dispensing unit should be one of the required components to be tested for external leaks under 1.5 times working pressure between 3 MPa and up to 26 MPa, as mentioned in United Nations Regulation No. 110. In addition, all the CNG components should be tested for two-hour vibration resistance at 17 Hz with an amplitude of 1.5 millimetres in each direction [25]. However, there are still some questions whether such testing conditions are suitable for road and usage conditions in Thailand or not. Therefore, robustness and durability are necessary to be conducted in the field test for safety assessment.

Figure 9 Locations of the CNG dispensing and filling units in the fire-gutted bus.

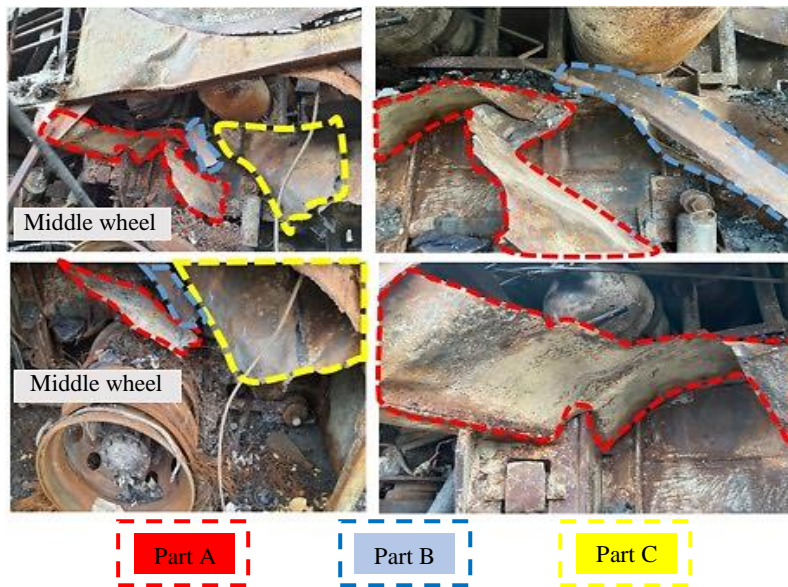
As shown in Figure 10, the broken metal sheets of the wheel well were bent downwards to the middle wheel on the right side of the vehicle. This occurred at the same axle on the left side of the vehicle, as shown in Figure 11. Such a bent wheel well might have occurred from the gas leak explosion at the loosened connector and the blocked tube near the CNG dispensing unit. Furthermore, the rigid fuel line for the vertical CNG container was located near the outer body, as shown in Figure 12. According to United Nations Regulation No. 110 and Thai CNG standards, the rigid fuel line should be secured without vibration stress and be fitted with protective material. Although the fire-gutted bus was approved for the installation of a rigid fuel line, it could not protect the gas leakage from the side impact at low-speed collision. In addition, the structure frame that mounted the CNG containers had an unwelded gap during installation, as shown in Figure 13. If this bus was subjected to frontal or side collisions, the mounting structure for the CNG containers could have been easily dislocated.

Figure 10 Broken metal sheets of wheel well above middle wheel at right side of vehicle.

To prevent the risks of CNG and rigid fuel installation, an experimental method should be used for the assessment instead of the calculation method as required by United Nations Regulation No. 110 and Thai regulations. Furthermore, monitoring and directing DLT-authorized inspectors should be enhanced because each inspector can have a different attitude for the visual assessment of defects (the visual inspection method is described in detail).

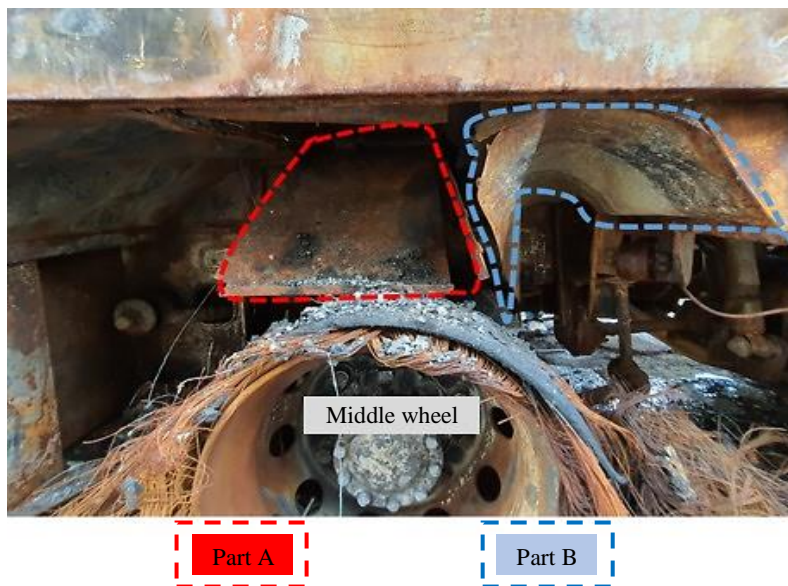
Figure 11 Downwards deformation of wheel well at left side of vehicle.

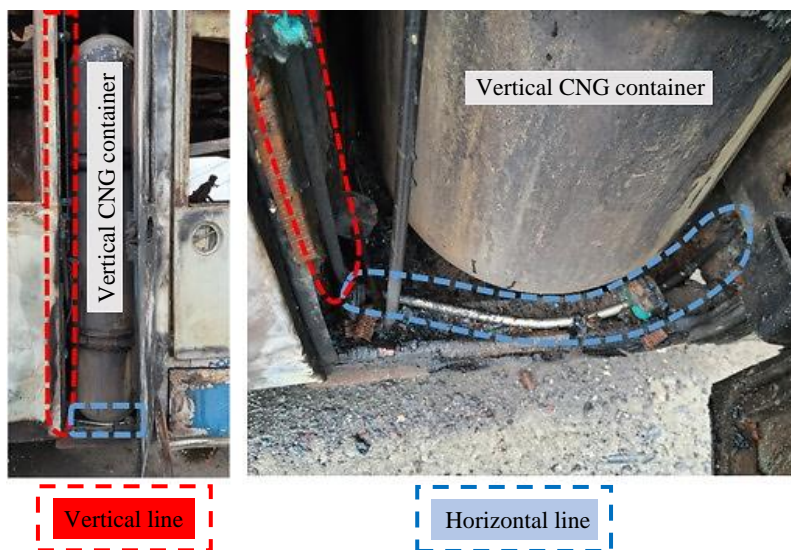
Figure 12 Location of rigid fuel line for vertical CNG container at right side of vehicle.

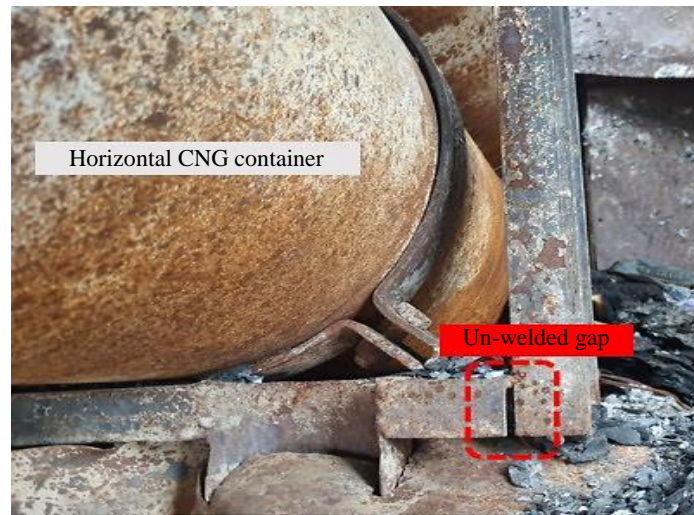
Figure 13 Poor mounting structure of CNG container near dispensing unit.
