ปัญหาและความเสียหายของโครงสร้างเหล็กในประเทศไทย Problem and Damage of Steel Structure in Thailand

Warakorn Tantrapongsaton and Tawee Chaisomphob*

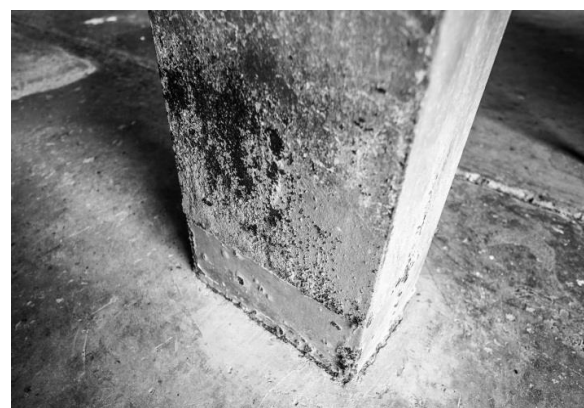
Fig. 2 shows a severe corrosion on the steel column in the power plant located on the southern part of Thailand, around 1 kilometer from the sea shore. This power plant has a periodic maintenance every five to ten years, causing the deterioration of the paint and corrosion. According to ISO 4628, that the paint has the degree of blistering of 5(S3), and the degree of rusting of 4(Ri4). Those were considered as severe level of damage.

Fig. 2 Corrosion on the steel column in power plant

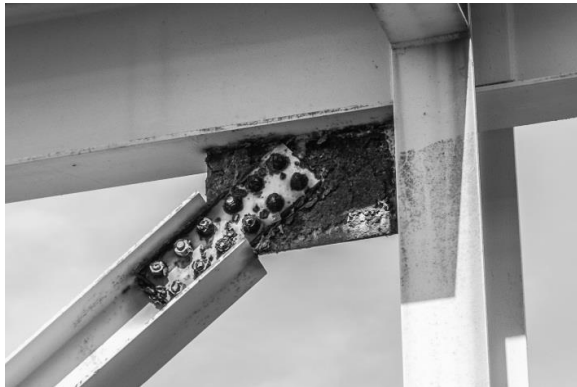
Fig. 3 and Fig. 4 show severe corrosion at the steel connection of a power plant structures, located on the eastern part of Thailand, around 50 meters from the river mouth. The water in the river was brackish water, which contain high chloride. This caused severe corrosion to the steel structure and the steel connections.

Fig. 3 Corrosion at steel bolt and plate in power plant

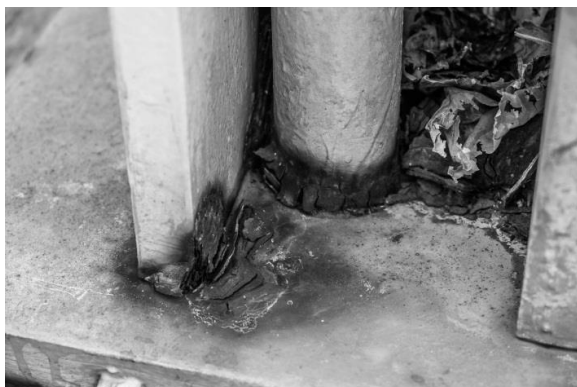
Fig. 4 Corrosion at weld of the column in power plant

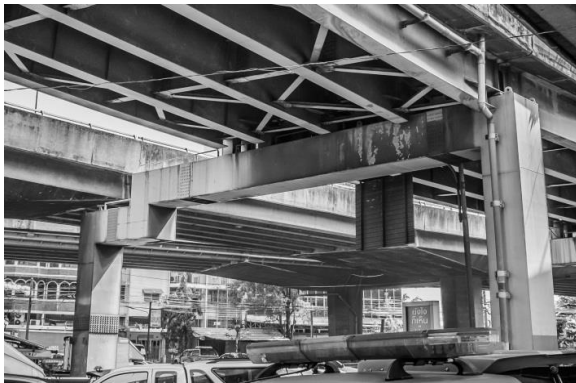
Fig. 5 Steel expressway with deteriorated coating

Fig. 5 shows the deterioration of coating on steel expressway due to long service life of the coating and the environmental damage.

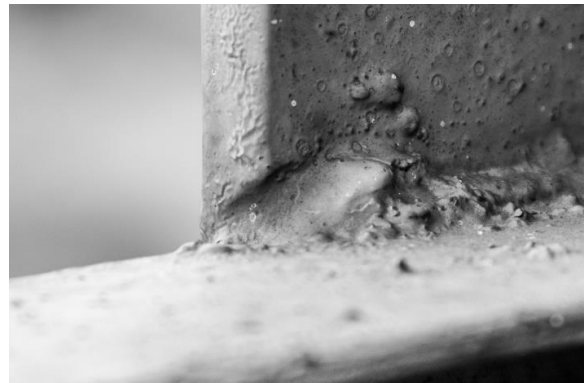
Fig. 6 shows the defect called "undercut" which is one of the most severe defects for welding connection, because undercutting will decrease the steel sectional area causing a decrease in structural capacities. In this case, the size of undercut is 4.6 millimeters which are unacceptable according to the criteria that in DPT 1561-51, "Undercut shall not exceed 2mm

for any length of weld for material equal to or greater than 25mm thick"; [1].

Fig. 6 Undercut at the weld on steel billboard

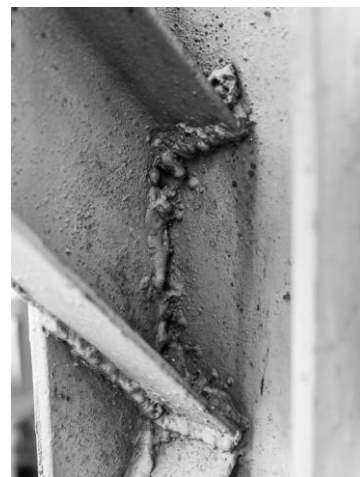
Apart from the undercut, the welding defects that were clear noticeable are porosity and incomplete fusion (shown in Fig. 7). These types of defect can cause the capacity of the weld to be decrease due to the decreasing of weld area. The criteria for porosity and incomplete fusion in DPT 1565-51 are "Diameter summation of piping porosity which has $> 1\text{mm}$ diameter shall not exceed 10mm in each 25mm of weld length for fillet weld" for porosity and "Incomplete fusion is unacceptable for fillet weld"; [2] for incomplete fusion. This, in this case was clearly unacceptable.

Fig. 7 Porosity and incomplete fusion of weld on a steel billboard

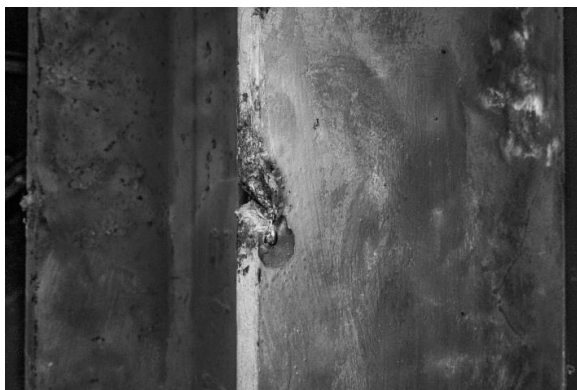
The first site is an old building over 20 years old that has never been maintenance or inspection activity since it was built. The result shows that, the quality of the connection (all weld connection) was poor and damaged, caused by welding procedure, such as slag, burning point or hole on the steel section, and the melted or cut spot on the steel sections as shown in Fig. 8.

Fig. 8 Missing steel section melted by poor welding procedure

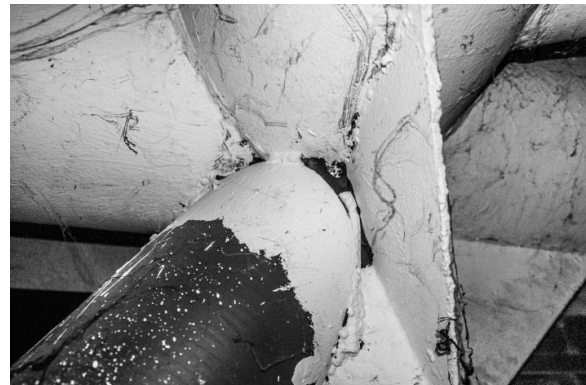
The second site is a roof structure of a convention hall, constructed by steel pipe with weld connection. The result shows that, some of

the weld connections were constructed poorly, as shown in Fig. 9.

Fig. 9 Discontinuity of weld on steel pipe roof structure

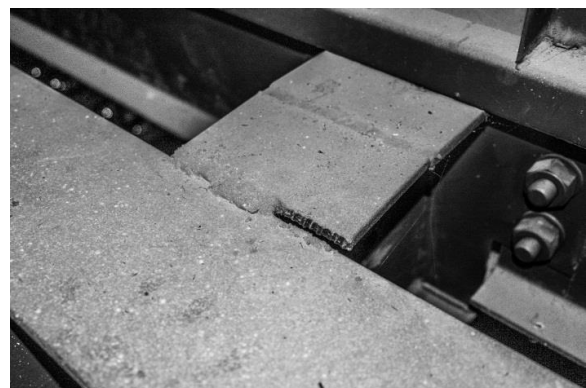
Fig. 10 shows the incomplete welding of the beam girder (over 40% of the weld was missing).

Fig. 10 Missing weld on steel beam girder

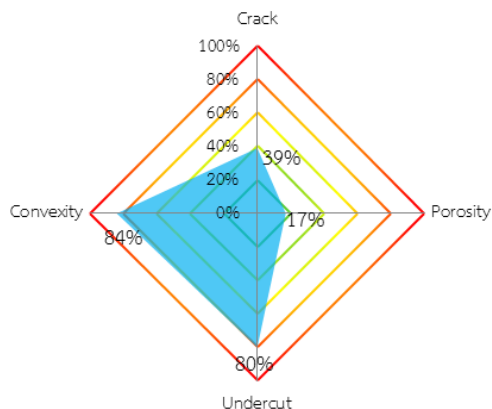
The result shows that the majority of the welds had defect on the surface, especially convexity and undercut, which exceed the standard limit in DPT 1561-51; [1]. The evaluation of the weld defect was classified as “unacceptable”, and the percentage of the welds that was unacceptable for this site is showing in Fig. 12.

Fig. 12 Amount of welding defect found on 64 of welds (in %)

From the inspection results, it concluded that the defect of the welding came from poor workmanship because of the welding procedure. Therefore, it is clear that this site has not done

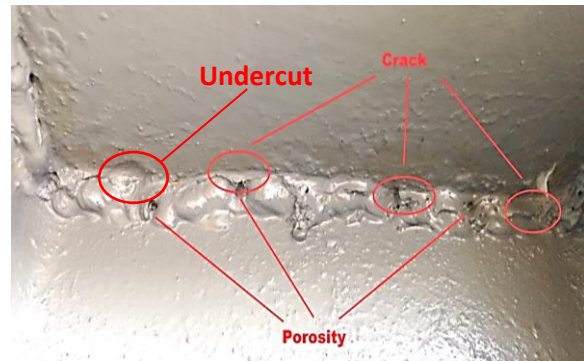
Fig. 13 shows the welding defect found at the beam-column joint of a steel structure.

Fig. 13 Welding defect found on beam-column welding connection
