In-depth intercity bus crash investigation: Case study of fire-gutted bus in Thailand

4. Results and discussion: Case study of fire-gutted bus

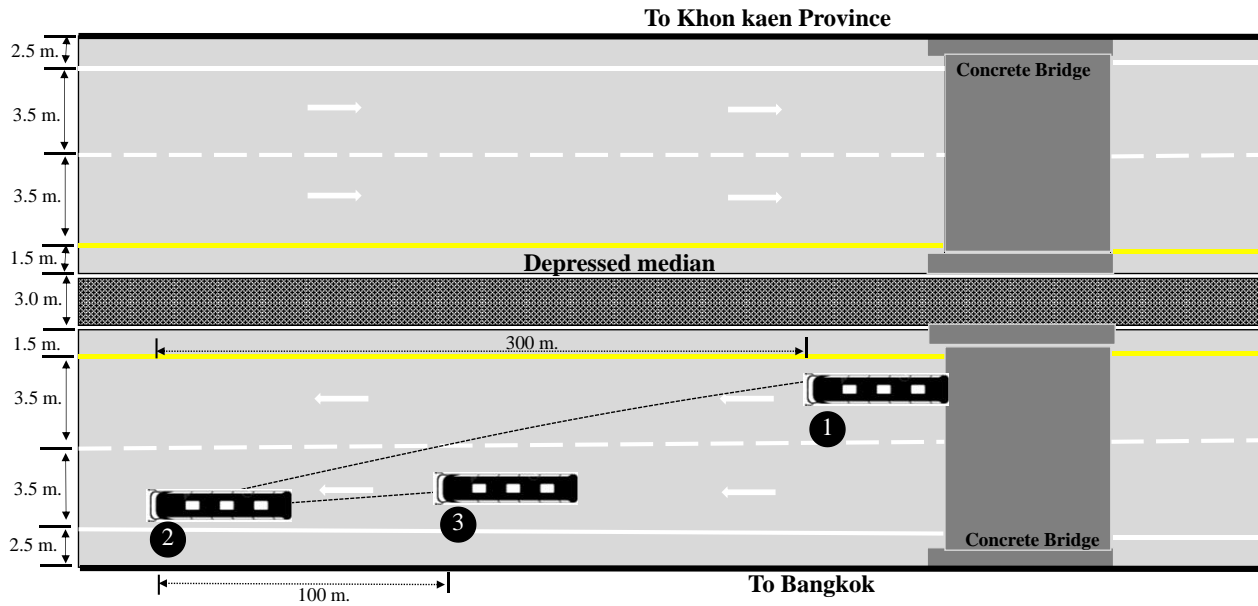
Figure 2 The bus accident scene diagram

In 2021, at around midnight during the Songkran festival of Thailand, a CNG double-deck bus was running en route from the Buengkan province to Bangkok along the divided four-lanes highway (two lanes in each direction) and burst into flames after CNG refilling. As illustrated in Figure 2 and based on the limited direct interviews with some victims, at the beginning of this single-vehicle accident, a rear-left tire burst and then the flames started at the rear parts of bus, where the engine compartment was located (point 1). Then, the driver tried to stop the bus for the occupants to safely escape from the fire. However, the explosion of the CNG tank

immediately occurred after the bus was temporarily stopped (point 2) located approximately 300 meters further from the beginning of the incident. Subsequently, the bus moved slowly backward for about 100 meters (from point 2) and finally ceased (point 3). At this point, the entire bus was ablaze. In addition, the fire-gutted bus was officially approved for the recent (less than one month) vehicle inspection prior to the incident. This detrimental accident caused 5 fatalities and 12 injuries, while the total number of a driver and all passengers were 33.
