ปัญหาและความเสียหายของโครงสร้างเหล็กในประเทศไทย Problem and Damage of Steel Structure in Thailand

Warakorn Tantrapongsaton and Tawee Chaisomphob*

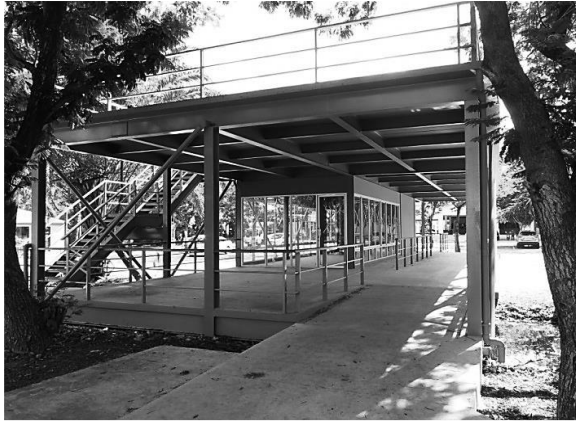
Fig. 11 Welded steel structure

A simple welded steel structure (shown in Fig. 11) that was built in 2014 was thoroughly inspected based on DPT 1561-51; [1] visual inspection criteria and evaluated based on four types of welding defect, which are crack, undercut, porosity, and convexity similarly to the billboard inspection.
