FATIGUE DAMAGE OF 2024-T351 ALUMINIUM ALLOY FRICTION STIR WELDING JOINTS. PART 2: FATIGUE DAMAGE

Aidy Ali^{1*}, Mike W. Brown² and Omar Suliman Zaroog¹

Keywords: 2024-T351 Aluminium alloy, crack coalescence, fatigue, friction stir welding

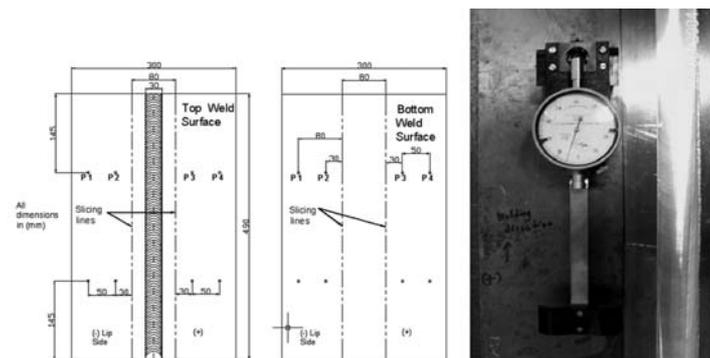
Figure 1. Measured strain location with Demec dial gauge

ties of the real FSW weld joints as shown in Figure 1.

Stress reliefs measured from the Demec dial gauge after slicing were 0.263 MPa and 0.2418 MPa for the top and bottom welded plate

surfaces respectively, which are considered small and negligible. Having quantified the amount of residual stress relief from slicing the specimens, we confirmed that the chosen specimen dimension was not distorted by the initial residual stress induced from the weld processing.

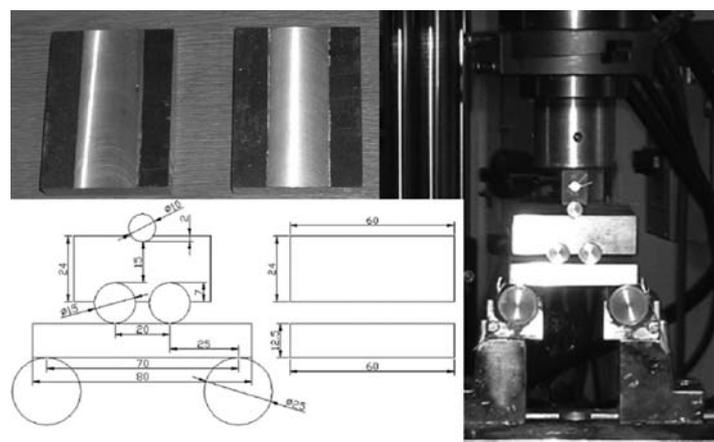
Figure 2. The specimen image and bending test configuration

Fatigue endurance tests were carried out on a longitudinal specimen with a length of 80 mm and width of 60 mm in a four-point bending test in accordance with ASTM D6272 (ASTM 1998) at a constant load amplitude, constant frequency of 20 Hz, and a stress ratio R of 0.1. The specimen and bending test configuration are shown in Figure 2 which provides the uniform stress area encompassing the main features of the weld regions. In order to see the effect of surface roughness and defects, the welded specimens surfaces were mechanically polished to a $1/4$ micron finish. Fracture surfaces

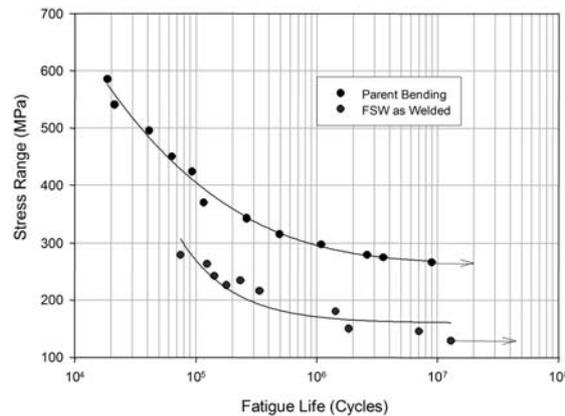
Figure 3. Stress life curves for FSW as welded versus parent plate of 2024-351 AL Alloy with load ratio $R = 0.1$

Figure 3 represents the stress vs. number of cycle to failure (S-N) data for the parent material and FSW as-welded specimens. Obviously there is a tremendous drop in the fatigue strength of FSW as-welded compared with the parent plate. Since surface irregularities can degrade the fatigue strength, Figure 4 shows the S-N data for FSW as-welded and FSW

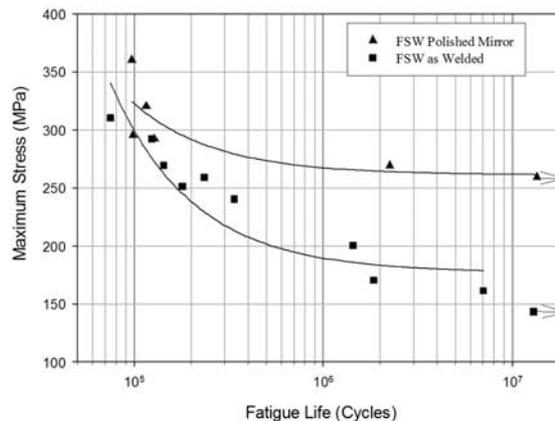
Figure 4. Stress life curves for FSW as welded versus FSW polished mirror of 2024-T351 AL Alloy with load ratio $R = 0.1$

mirror-polished specimen. It is worth noting that there is a significant life improvement was found, specifically in the high cycle fatigue (HCF) regime when the surface irregularities were removed by the mechanical polishing. Fatigue is hailed as a defect sensitive property. As a rule of thumb, any parameter that will increase the local stress concentration will also degrade fatigue performance. How surface irregularities can degrade fatigue strength, especially in the HCF regime is investigated using SEM and EDX analysis. In order to investigate the initiation origin and its causes, two fracture surfaces were taken from the HCF and low cycle fatigue (LCF) regimes in both FSW as-welded and FSW polished mirror and were examined.

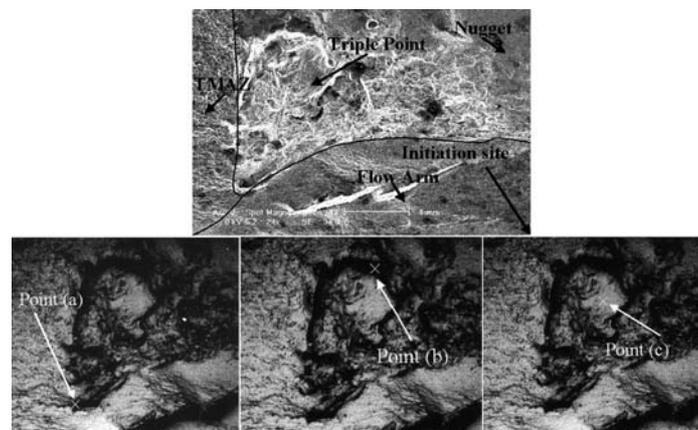
Figure 5. SEM fractograph and EDX analysis position of initiation images for LCF of 2024-T351 AL Alloy FSW as welded specimen at 292 MPa applied stress with load ratio $R = 0.1$

Further investigation was carried out to take advantage of the higher resolution in SEM and, working together with the EDX analysis, revealed the initiation site in FSW. Figure 5 illustrates the initiation site in the LCF FSW as-welded. It is evident that the crack was initiated from the free surface, propagating to the triple point regime, and causing a severely fractured surface. We used the EDX analysis to investigate any inclusion in the triple point location at several positions which were labelled as Point (a), Point (b) and Point (c) as shown in Figure 5. Table 1 represents the chemical composition of the material at each position of interest from the EDX analysis. Point (b) exhibits an enormous amount of oxygen (54.43%) which is believed to cause formation of the severely fractured surface that accelerates the crack growth and which is located approximately 3 mm from the top free surface of the weld. Nevertheless, both position Point (a) and (c) exhibit small amount of oxygen confirmed by the mechanism in the triple point regime where the grain is severely elongated due to stirring in the FSW process.

Table 1. Chemical composition of the material at certain positions analysed from EDX for LCF of 2024-T351 ALAlloy FSW as-welded specimen at 292 MPa applied stress with load ratio R = 0.1

Elements	Point (a) (%)	Point (b) (%)	Point (c) (%)
O	8.63	54.43	2.78
Al	85.75	41.70	91.49
Mn	0.65	0.46	0.64
Fe	0.26	0.07	0.24
Cu	4.71	3.34	4.85

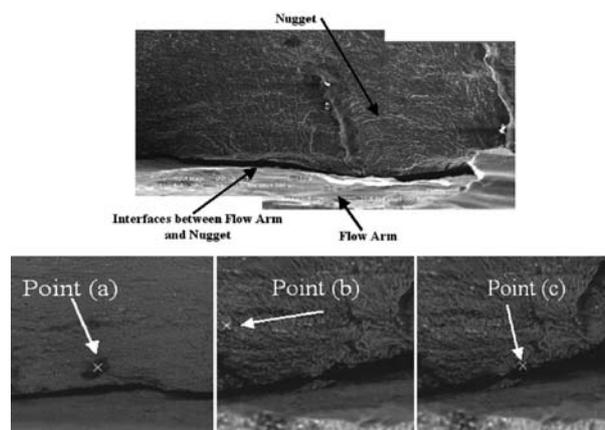
Figure 6. SEM fractograph and EDX analysis position of initiation images for LCF of 2024-T351 AL Alloy FSW polished mirror specimen at 300 MPa applied stress with load ratio $R = 0.1$

In the LCF of the polished sample, the initiation site started at the transition zone

between the Flow Arm and Nugget regime with approximately 50 - 100 μ m depths as shown in Figure 6. EDX analysis which was performed at three positions of interest shown in Figure 6. The figure revealed that, one of the cracks started from broken or debonded precipitate at Point (c) and oxygen was also found in this transition zone as shown in Figure 7. It is worth noting that one of the initiations was mainly started at a silicon oxide inclusion at Point (a) which contains 66.42% of silicon and 11.25% oxygen as summarised in Table 2; that caused the subsurface crack initiation to occur. Further EDX analysis passing the transition zone at Point (b) revealed there is no clear indication of an inclusion and a high amount of trapped oxygen.

Table 2. Chemical composition of the material at certain positions analysed from EDX for LCF of 2024-T351 ALAlloy FSW mirror-polished at 300MPa applied stress with load ratio R = 0.1

Elements	Point (a) (%)	Point (b) (%)	Point (c) (%)
O	11.25	2.19	5.82
Al	16.16	92.99	91.11
Mn	0.34	-	1.01
Fe	1.24	0.10	-
Cu	2.57	4.13	2.06
Si	66.42	-	-
Ti	1.67	-	-
Ni	0.35	-	-

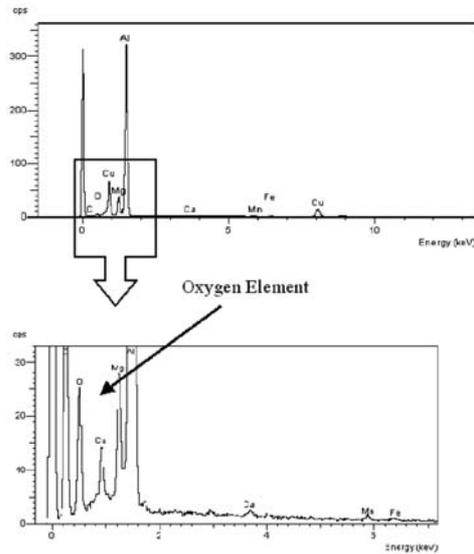
Figure 7. EDX analysis showed that the chemical composition of the material at position point (c) LCF of 2024-T351 ALAlloy FSW polished mirror specimen at 300 MPa applied stress with load ratio R = 0.1

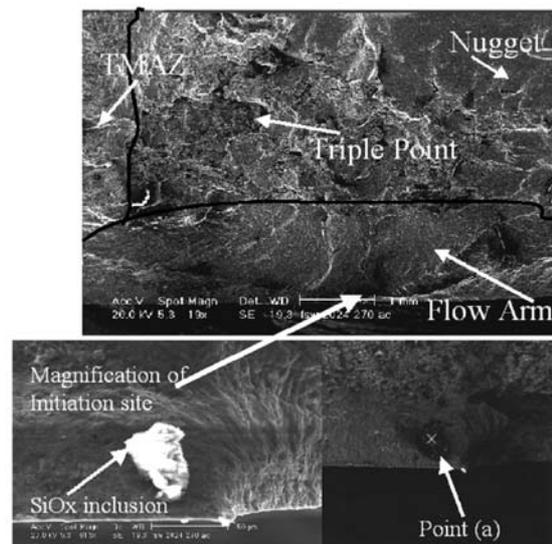
Figure 8. SEM fractograph and EDX analysis position of initiation images for HCF of 2024-T351 AL Alloy FSW polished mirror specimen at 270 MPa applied stress with load ratio $R = 0.1$

For the HCF of the polished sample, when the crack surface was observed at high magnification, the crack initiation point was shown to have initiated inside the Flow arm causing severe damage experienced by the material at the triple point regime as illustrated in Figure 8. In order to reinforce the idea that the inclusion was part of the material prior to failure, EDX spots at Point (a) in Figure 8 were selected at the perimeter of the inclusion. As a result, a white feature in Figure 8 was analysed and found to contain an inclusion with 67.07% silicon and 12.13% oxygen in the composition as summarised in Table 3. Further high magnification near

Table 3. Chemical composition of the material at certain position analysed from EDX for HCF of 2024-T351 AL Alloy FSW polished mirror at 270 MPa applied stress with load ratio $R = 0.1$

Elements	Point (a)
O	12.13
AL	16.25
Mn	0.34
Fe	1.25
Cu	2.60
Si	67.07
Ni	0.35

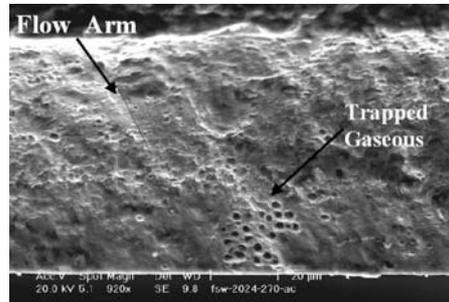
Figure 9. SEM fractograph confirm the existence of trapped gaseous elements at near surface depth within the flow arm for HCF of 2024-T351 AL Alloy FSW polished mirror specimen at 270 MPa applied stress with load ratio $R = 0.1$

the surface, by SEM analysis, confirmed the existence of trapped gaseous elements within the Flow Arm as shown in Figure 9.

5. The Severely fractured surface in the triple point regime is due to trapped gaseous elements found located at 3mm depth from the surface.

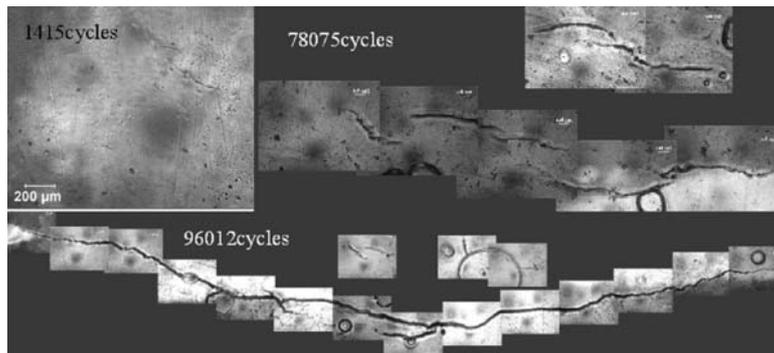
Figure 10. Replica images for LCF of 2024-T351 AL Alloy FSW polished mirror specimen at 300 MPa applied stress with load ratio $R = 0.1$

Having analysed the SEM and EDX results, the fatigue initiation of FSW 2024-T351 AL Alloy was influenced by material defects such as inclusion and porosity. Replica images for the mirror-polished LCF specimens in Figure 10 confirm the occurrence of multiple crack initiation, causing crack coalescence and overlapping. On the other hand, the replicas images captured from the HCF of the polished samples shown in Figure 11 confirm a single crack initiation and propagation until final fracture.

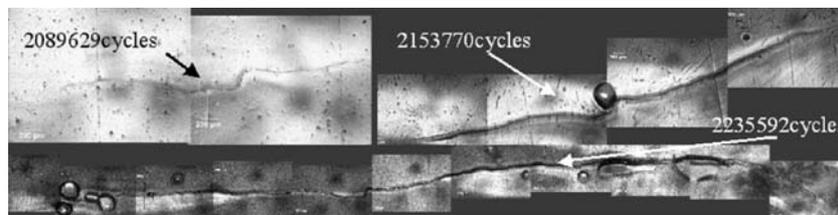
Figure 11. Replica images for HCF of 2024-T351 AL Alloy FSW polished mirror specimen at 270 MPa applied stress with load ratio $R = 0.1$
