# Comparative Performance of a Substandard Beam-Column Joint with and Without Initial Bond Between Beam Bars and Concrete in the Joint Core

This paper presents the test of a beam-column joint with and without bond between concrete and longitudinal bar in the joint. The specimens are half-scale, typical of substandard actual beam-column joint of mid-rise reinforced concrete frame buildings constructed in Thailand. In Thailand, the design and construction of RC frames do not normally take into account the seismic loading. For the control specimen with full bonding, the failure was suddenly caused by crushing of a concrete strut. The energy was dissipated through diagonal cracks in the joint. On the contrary, for the specimen with debonded longitudinal reinforcement, little damage was observed in the joint. The joint remained sound throughout the entire loading. The deformation was concentrated as a fixed end rotation around the interface between the joint face and beam. As a result, the energy was mainly dissipated at the interface rather than at the joint. Either mode of failure was undesirable in terms of energy dissipation. However, the drop in load after peak of the debond speci

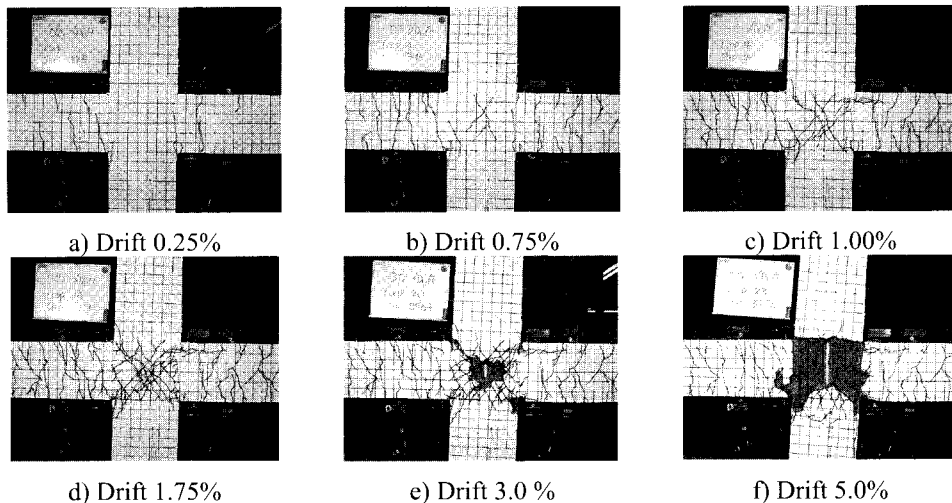
**Figure 6** Crack development in control specimen

The cracking behavior of the control specimen is illustrated in **Fig. 6**. At  $\pm 0.25\%$  drift ratio, flexural cracks developed as first cracks on the beam. At  $\pm 0.5\%$  drift ratio, the first diagonal crack occurred at the joint. As the drift ratio increased, these flexural and diagonal cracks grew in size and numbers. At  $\pm 0.75\%$  drift ratio, a splitting crack along the longitudinal beam bar in the joint was observed.

After a  $\pm 1.0\%$  drift ratio, the cracks were mainly concentrated in the joint region. These cracks were intersecting diagonal cracks with typical X-shaped pattern as shown in **Fig. 6**. On the other hand, no more flexural cracks were observed in the beam. The specimen reached a peak load of 72 kN at 1.75% drift. At  $\pm 2.0\%$  drift ratio, the concrete in the joint region spalled off, exposing column longitudinal bars. The load was continued with significant damage concentrated in the joint region until  $\pm 5.0\%$ .
