## **Retrofit Historical Masonry Walls with GFRP under Seismic Loading**

Restoration of historical structures is a durative and arduous work in many countries. This research determines the seismic behavior of historical masonry walls in Thailand retrofitted by glass fiber reinforced polymer (GFRP) through the experimental method. Five masonry wall specimens were built in the traditional method in Thailand and tested under horizontal cyclic loading without vertical axial load. One wall served as reference specimen without retrofitting. Three walls were retrofitted with GFRP in different modes before loading. One wall was repaired after predefined damage and retrofitted with GFRP before secondary loading. The failure mechanism, shear strength, ductility and energy dissipation of walls were studied in detail. The results show that the shear strength and energy dissipation capacity of the historical masonry walls were distinctly improved after GFRP strengthening.

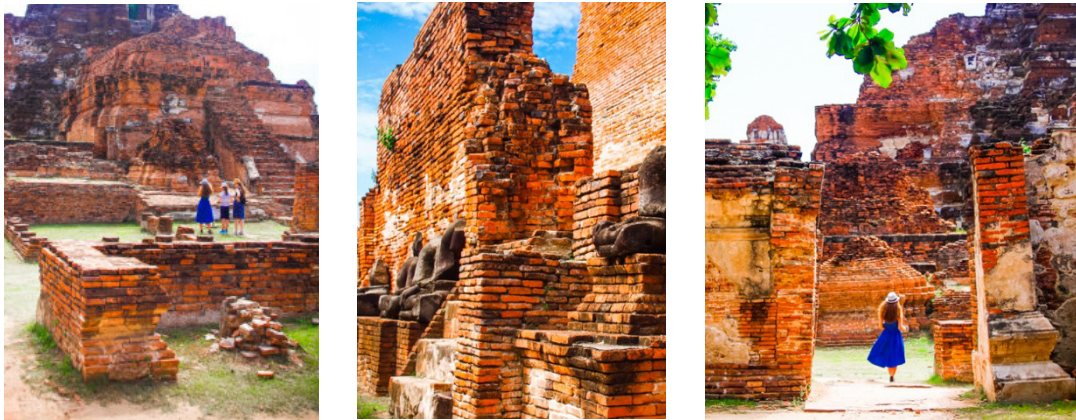
**Figure 1** Historical masonry walls in Thailand.

In Thailand, many historical buildings have been designated by UNESCO as World Heritage sites, due to their cultural value in Buddhism. Most of them were made of bricks around the eleventh and the twelfth Buddhist centuries. Earthquakes, soil settlements, and strength degradation of materials, due to wind and weather, are high risk factors for these architectural heritages. Many historical constructions have collapsed. In recent years, the Bureau of Archeology and Museums in Thailand has paid more attention to the restoration of these historic structures. Some traditional retrofit methods were used, such as repairing with an external layer of reinforced concrete or cement paste and external un-bond steel wire. However, there were multiple reports of failure after these restorations [1,2].

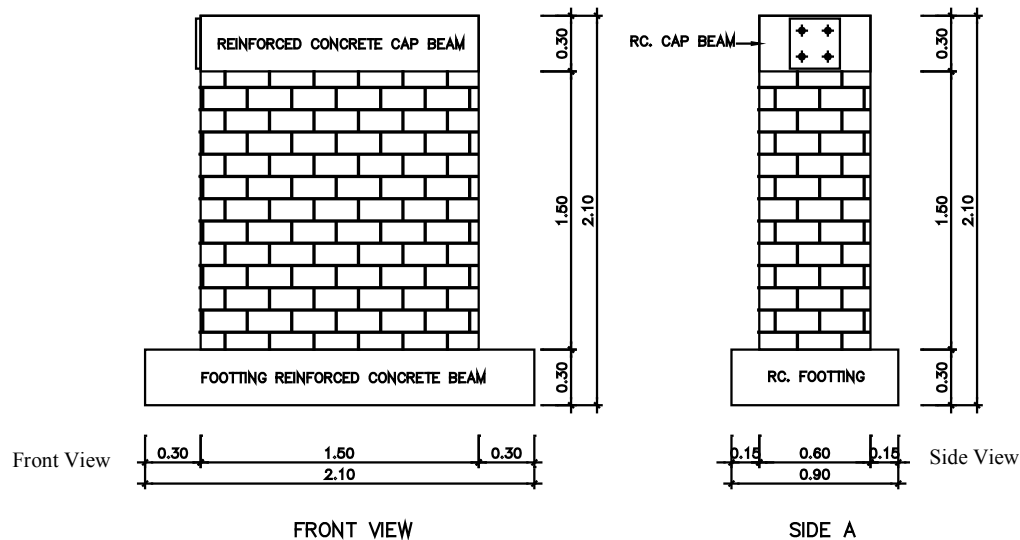
**Figure 2** Dimensions of specimen walls.

Five wall specimens were constructed with mortar joint of 10 mm thickness. All specimens were chosen with an aspect ratio of 1.0 to ensure that most of the walls would exhibit shear-induced damage. The nominal dimension of the wall was 1500 mm wide  $\times$  1500 mm high  $\times$  600 mm thick (**Figure 2**). They were representative of a typical un-reinforced historical masonry wall, built 300 to 400 years ago at Ban Lum Plee, Ayutthaya, Thailand.

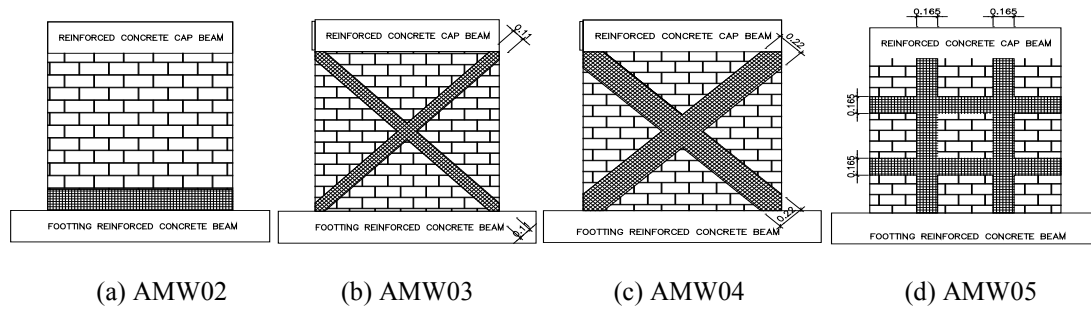
Specimen AMW01 was un-reinforced, as a reference wall. After failure, all cracks of AMW01 were patched with epoxy. One 200 mm-wide GFRP stripe was then pasted in a horizontal direction along cracks on each side of the wall. The specimen was then taken as specimen AMW02 (**Figure 3a**) and cured for at least one week before being subjected to the secondary loading test. Three different GFRP retrofitting patterns with the same GFRP strengthening ratio in area (= area of GFRP sheets/area of wall face) of 0.40 were used for the other 3 specimens before testing (**Figures 3b - 3d**). Specimen AMW03 was reinforced with 2 110 mm-wide GFRP stripes diagonally on both sides. Specimen AMW04 was reinforced with 2 220 mm-wide GFRP stripes diagonally on just one side of the wall. Specimen AMW05 was reinforced with 4 165 mm-wide GFRP stripes orthogonally on just one side of the wall.

Figure 3 Retrofitting patterns of specimens.

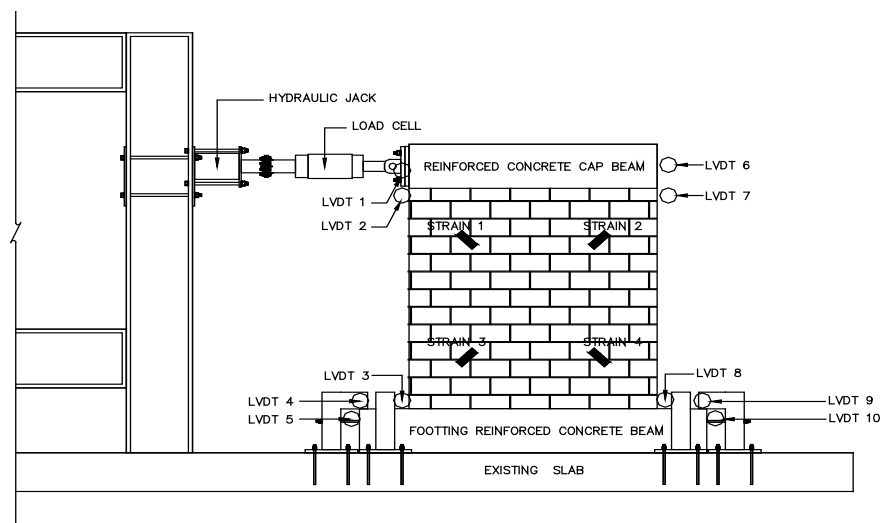
Figure 4 Test set-up.

In this test, no external axial compression was applied due to the inadequacies of the laboratory. The horizontal cyclic load was transferred through a cap beam to the wall. Ten LDVTs (Linear Variable Differential Transformers) were erected to control the lateral displacements of the wall and footing beam. Four strain gauges were glued onto the bricks and the GFRP sheets to monitor the strain development (Figure 4). In this quasi-static test, a force controlled scheme was followed until the first cracking of the wall, in increments of 2 kN. Then, a displacement controlled scheme was used to the point of failure, in increments of 1 mm. Each loading step performed one fully reversed cycle. It was defined as the failure point when the applied load reduced to 80 % of the maximum strength previously recorded.

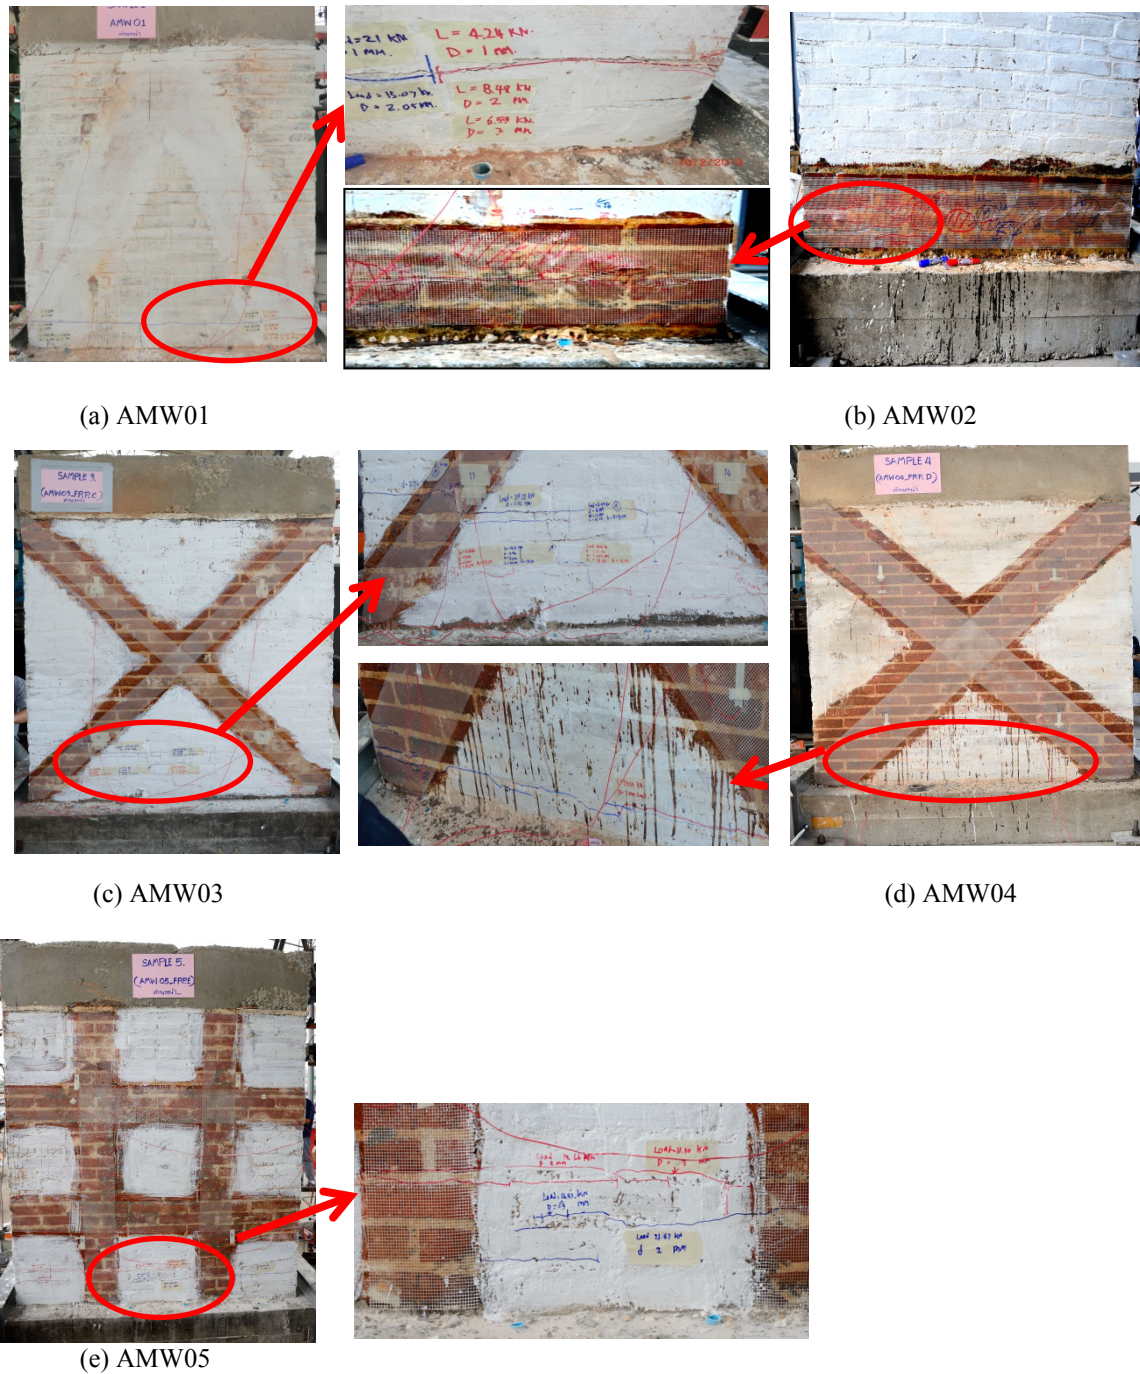
**Figure 5** Failure modes of five specimens.

As a reference specimen, wall AMW01 began to crack at the third course of mortar joints when the lateral load reached 8.3 kN. With the load increased, cracks developed along the mortar joints and throughout the whole cross section at the end. The failure mode presented was shear slide failure (Figure 5a). For AMW02, because GFRP stripes were well pasted along the cracked mortar joint in the specimen AMW01, the shear strength of the wall was significantly increased. The appearance of the first crack was delayed until the loading stage of 16 kN, equal to the maximum value of the lateral load which could be resisted by AMW01. The old cracks along the third course of mortar in specimen AMW01 opened again.

No new cracks were observed outside this region. At failure point, the GFRP stripes were peeled off at many positions. At the 2 ends of the third course of mortar joints, GFRP sheets were torn apart due to the wide cracks, as shown in **Figure 5b**.

For AMW03, the first cracking occurred at the bricks near the bottom corner when the lateral load reached 26 kN. Then more cracks appeared in several courses of mortar above the base joint and developed upward along the diagonal direction. The crack pattern is shown in **Figure 5c**. For AMW04, the first cracking started in the second course of mortar near the bottom corner of the wall when the load reached 26 kN. With the load increased, more horizontal shear sliding cracks developed at several courses of mortar joint near the base. Some cracks further extended towards the diagonal direction. The failure mode of AMW04 behaved as a combination of bricks crashing near the bottom corner and sliding, as shown in **Figure 5d**. When the lateral load of 18 kN was applied on wall AMW05, a slight crack was observed at the third course. Then, some horizontal cracks appeared in several courses of mortar near the base. The failure mode presented was shear slide failure (**Figure 5e**).

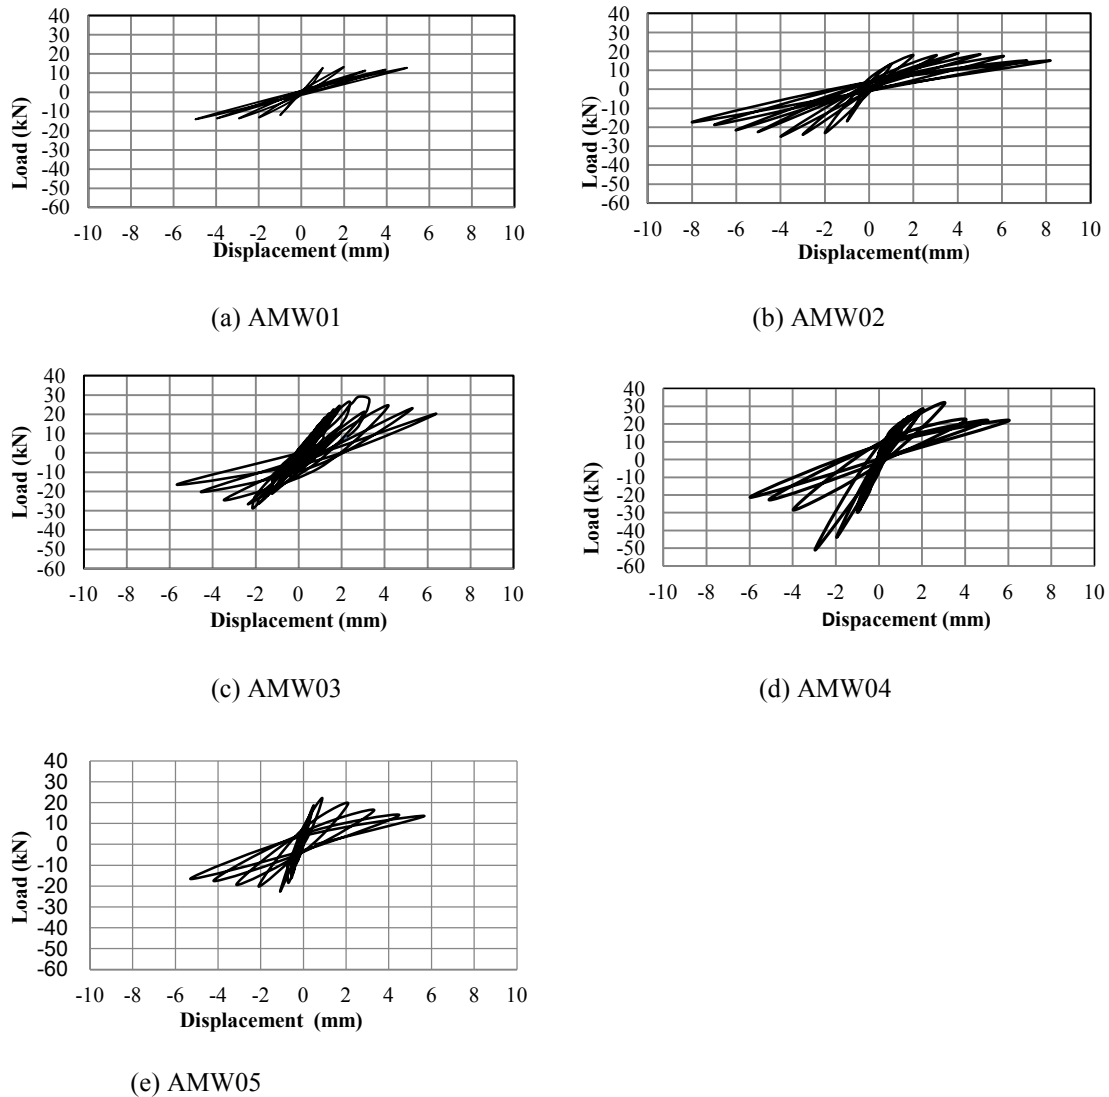
The hysteretic relationships of all wall specimens are presented in **Figure 6**. All the hysteresis loops showed a pinching phenomenon, which is the effect of shear deformation caused by slip. The hysteresis loop area gradually increased, showing a certain energy dissipation capacity. The hysteresis loops of reinforced walls were much fuller than that of un-reinforced walls, indicating a stronger energy dissipation capacity for resisting earthquakes.

**Figure 6** Hysteresis loops of 5 specimen walls.

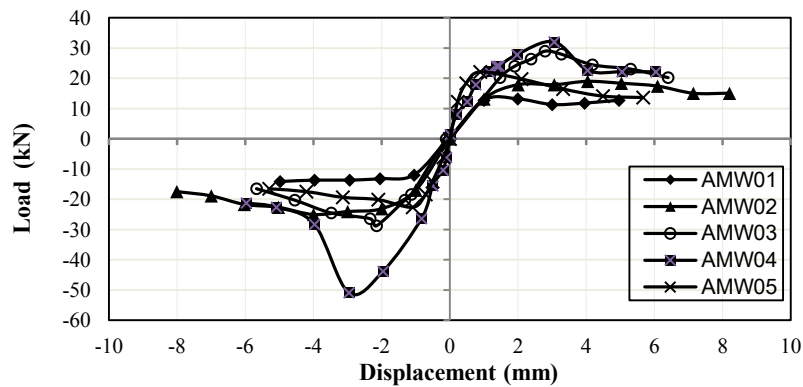
The lateral load-displacement envelopes are displayed in **Figure 7**. As can be seen from the envelope curves, shear strength of reinforced walls was increased. The inflection points did not appear in the curve at the cracking point and the strengthened section after cracking was small. For un-reinforced

specimen walls, the envelope curve steeply descended after reaching the maximum capacity, indicating the load bearing capacity decreased rapidly with little lateral deformation. For reinforced walls, the envelope curve slowly descended after reaching the maximum capacity, showing a better deformation capacity. The GFRP retrofitted walls can absorb more earthquake energy.

**Figure 7** Envelope curves of 5 specimen walls.

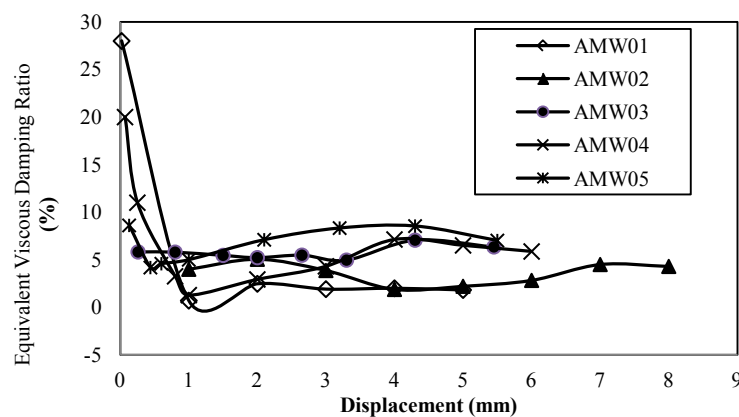
The energy dissipation capacity, expressed as the equivalent viscous damping ratio, was calculated as:  $\zeta_{eq} = A_n / 2\pi A_E$ , in which  $A_n$  represents the hysteretic damping or energy loss per cycle for one complete idealized load-displacement hysteresis loop, and  $A_E$  represents the elastic strain energy stored in the equivalent linear elastic system under static conditions with effective stiffness [12]. The values of the equivalent viscous damping ratios for the specimens are plotted in **Figure 8**.

**Figure 8** Equivalent viscous damping ratios at various displacement levels.

After the wall cracked, the equivalent viscous damping ratios gradually increased with a corresponding increase in lateral deformation of the walls. This was because the appearance and development of cracks and the friction at the brick-mortar interface dissipated large amounts of energy. At a given displacement level, the equivalent damping ratio of the reinforced wall was larger than in the unreinforced wall. The GFRP stripes obviously contributed to improving the energy dissipation capacity of the piles. This confirms the qualitative observations based on the shape of the hysteresis curves. Since the specimen AMW02 was only simply repaired, the energy dissipation capacity did not show a big difference.
